TECHNICAL SERVICE BULLETINS

APPLICABILITY: All Models
SUBJECT: Cylinder Head Gasket (residual carbon deposits and rubber coating removal)

NUMBER: 02-100-06R
DATE: 10/31/06

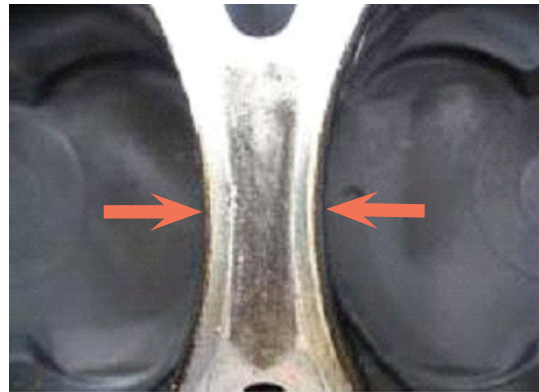
Carbon deposit on cylinder block bore sealing portion

Using a gasket scraper, carefully clean any carbon deposits and rubber coating found on the surface of cylinder block and cylinder head.

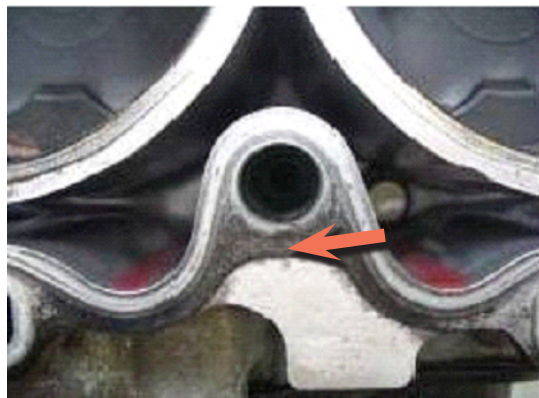
Rubber coating residue on oil sealing portion

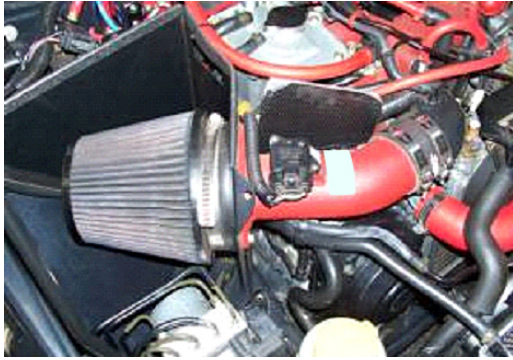
- Allow foreign objects to enter the engine.
- Change the Air/Fuel mixture ratio, due to the change of intake air amount.
- System malfunctions due to a contaminated air flow sensor.
- Reduced engine durability due to higher horse power that exceeds engine design specifications.
- Turbo charger internal damage from excessive turbine speed.

Aftermarket Cold Air Intake

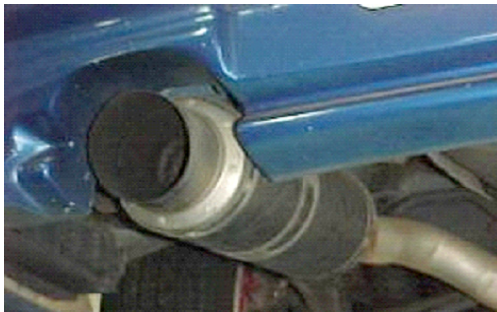
Modifications to the Exhaust System may create a reduction of exhaust resistance. This can lead to similar problems as found in Intake System modifications.

Aftermarket Exhaust System

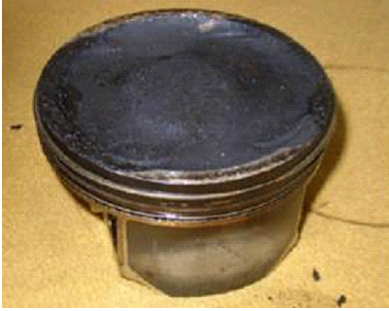
Modifications to the Engine Ignition System, such as “plugs”, can cause abnormal ignition, and result in engine damage.

Ring Land Damage from Detonation

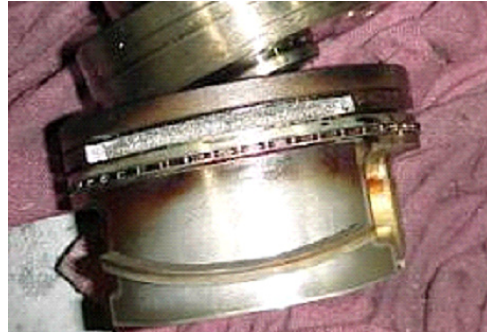
Ring Land Broken from Over Boosting

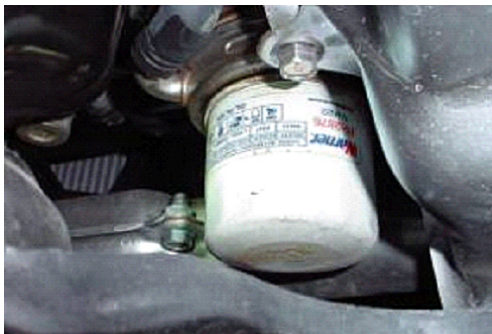
- The use of a Genuine Subaru oil filter is strongly recommended. Many aftermarket oil filters have different filtration capacity and relief valve opening pressure. Those filters may not meet Subaru's requirements and may cause engine problems.

Aftermarket Oil Filter

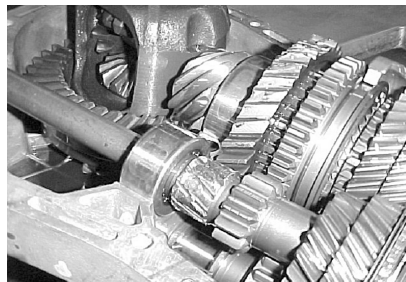
Some examples of abusive driving are exceeding maximum recommended RPMs, excessive torque transferred to the transmission during acceleration from a complete stop (dumping the clutch), downshifting at high RPMs and missing shifts.

First Gear Teeth Stripped from Mainshaft

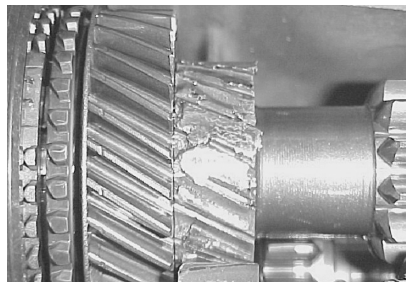
Second Gear Teeth Missing

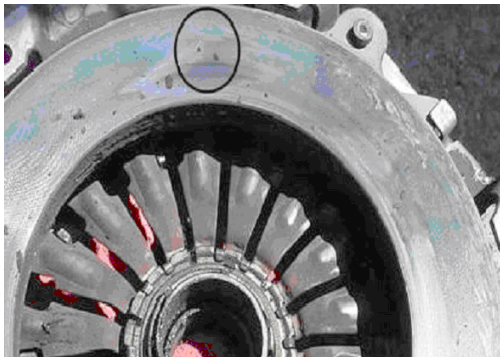
Over Heated Pressure Plate

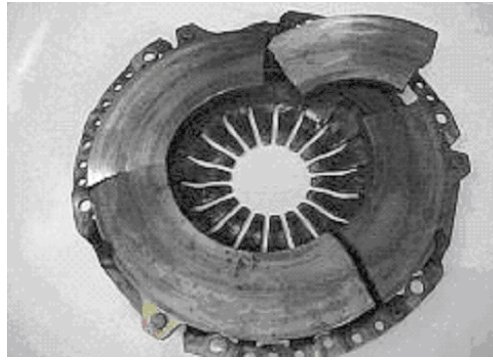
Broken Pressure Plate

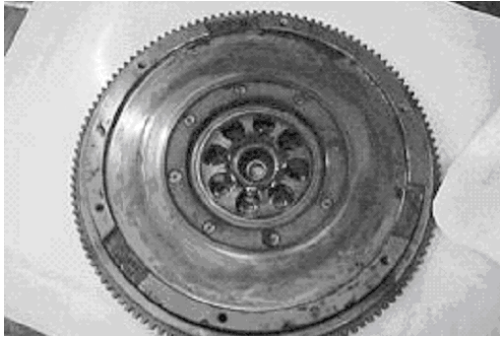
Over Heated Flywheel

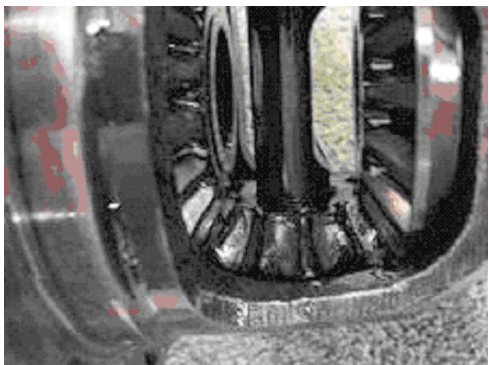
Rear Differential Gear Damage

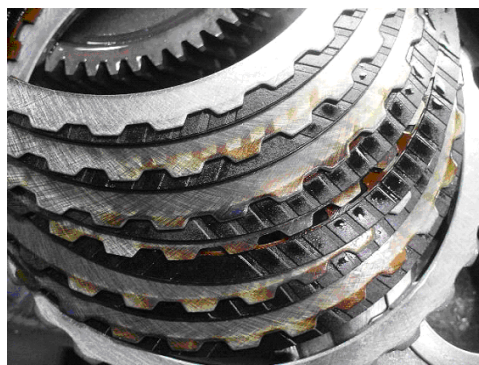
Burnt automatic transmission clutches

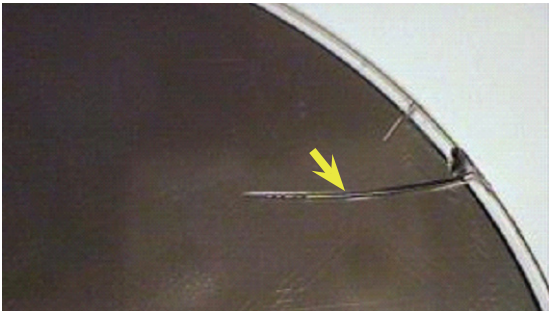
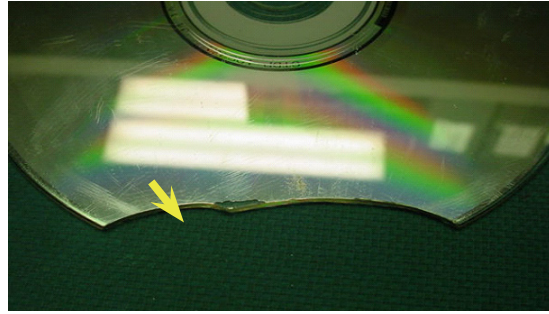
EXAMPLES OF BROKEN/CRACKED DISCS
