TECHNICAL SERVICE BULLETINS

APPLICABILITY: All Models
SUBJECT: Cylinder Head Gasket (residual carbon deposits and rubber coating removal)

NUMBER: 02-100-06R
DATE: 10/31/06

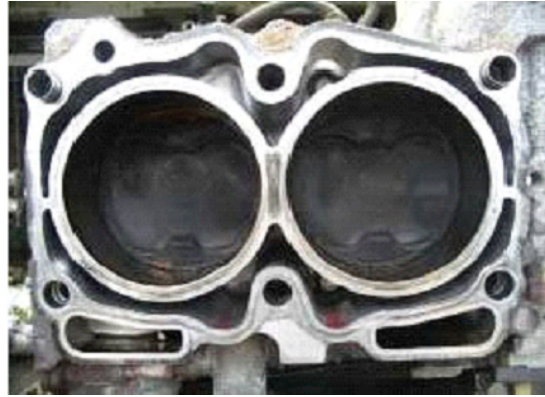
Finished cleaning (block)

NOTE: After removing carbon deposit and rubber coating, clean the surfaces using a rag and cleaning solvent.
