TECHNICAL SERVICE BULLETINS

APPLICABILITY: All Models
SUBJECT: Cylinder Head Gasket (residual carbon deposits and rubber coating removal)

NUMBER: 02-100-06R
DATE: 10/31/06

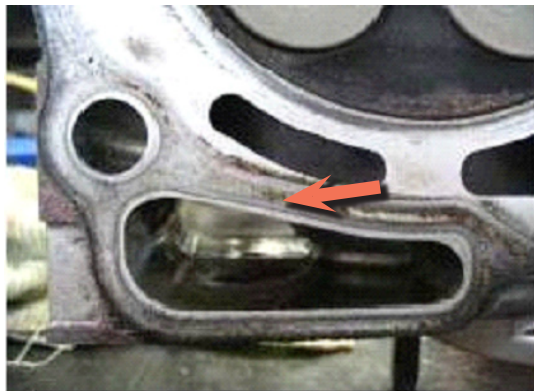
Rubber coating residue on oil sealing portion

Using a gasket scraper, carefully clean any carbon deposits and rubber coating found on the surface of cylinder block and cylinder head.

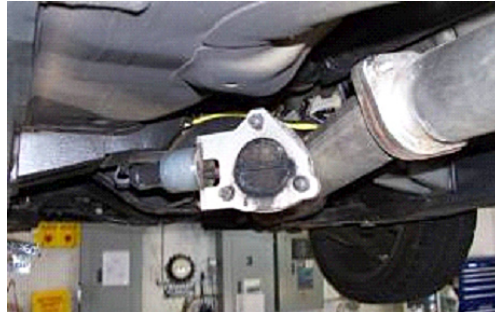
Aftermarket Exhaust Bypass Valve

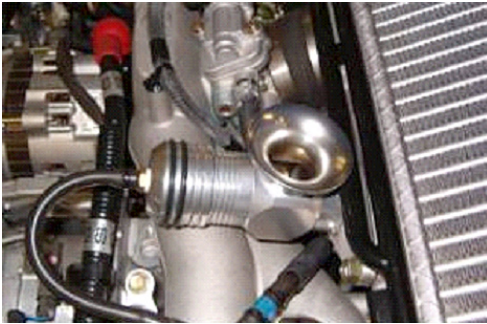
Aftermarket Blow Off Valve

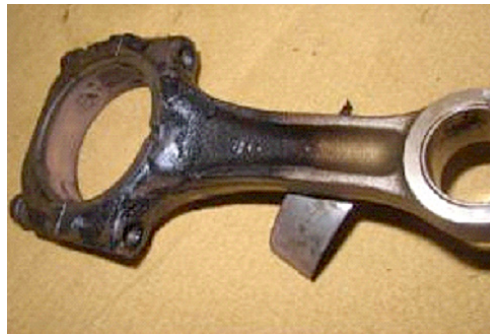
Rod Bearing Spun from Lack of Oil

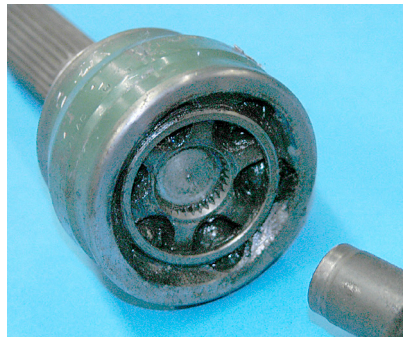
The following 3 photos show an axle shaft that was sheared off at the “Bell Joint” (BJ) as the result of abuse.

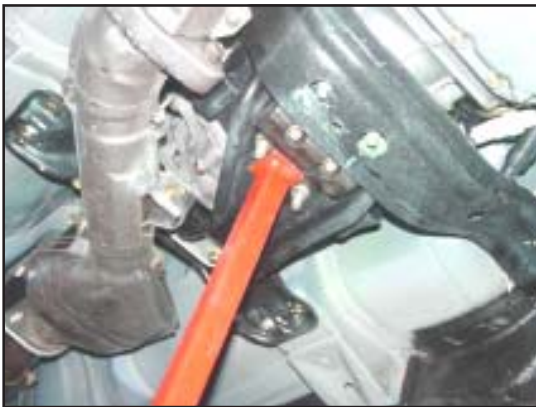
**Figure 1**

When performing service work or installing SOA's accessory short throw shifter, it is extremely important that the transmission is supported properly when removing or reinstalling the cross member. If not, damage to the bolts and/or threads will occur. Support the transmission using a transmission jack, regardless if the vehicle is supported by a lift or car ramps (**Figure 1**). It is recommended that hand tools be used for the removal and installation of the bolts. Inspect for bolt thread damage and replace as necessary. Be sure to clean any protective wax from the mating surfaces and be sure to start all bolts several threads by hand before using tightening tools. **Note: If severe damage is evident to the threads, the use of a Heli-coil® type kit is an approved repair method.**

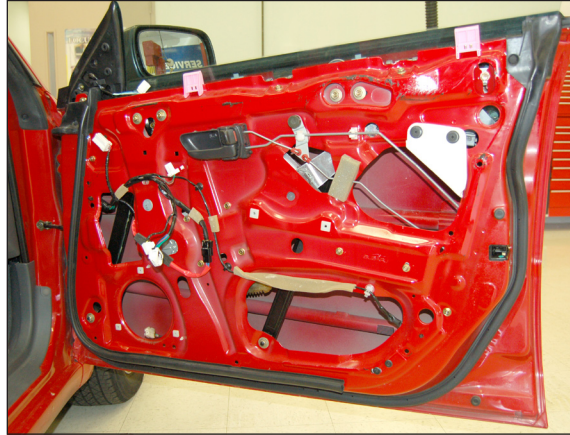
Countermeasure 1

- 1) Remove the door trim, speaker and sealing cover (see figure 1, below).

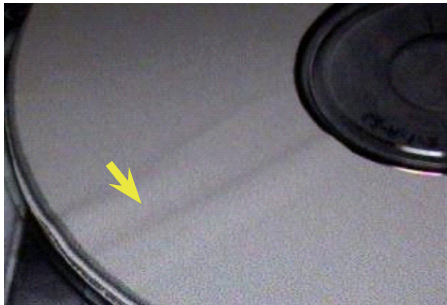
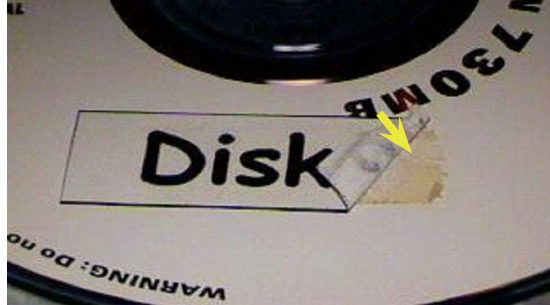
EXAMPLES OF PEELING LABELS

The purpose of this bulletin is to inform of cautions concerning compact discs. There have been an increasing number of changers/players being replaced under warranty. We have found that the majority of all failures are the result of the use of damaged CDs, non-compatible user-created CDs and labels, or multiple CDs inserted at the same time jamming the player or damaging the CD. The resultant damage to the player is generally not detected until after the audio exchange has been completed.

Customers coming in with CD changer/player issues should be reminded at the time of the unit exchange that the use of CDs as described above are the potential causes of problems.

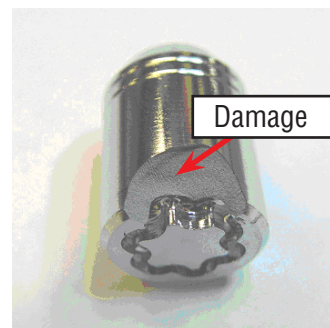
WARNING: Use of an impact wrench may cause permanent damage to the wheel lock and key.

NOTE: For ease of installation and removal, the wheel lock should always be the last lug nut tightened on each wheel and should always be the first one removed.
